Manhole Inspection Summary

Manhole # S45II_062MH

Insp Date: **4/29/08 9:33 AM**

Location Address: **Washington St**

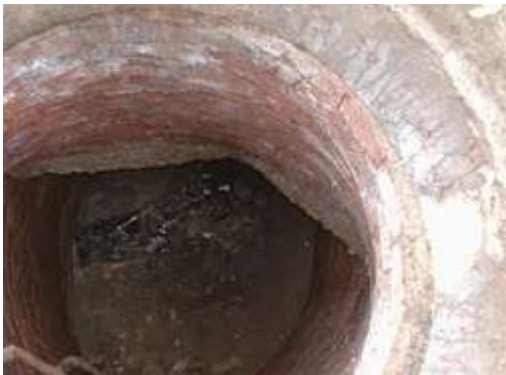
Defect 1

infiltration

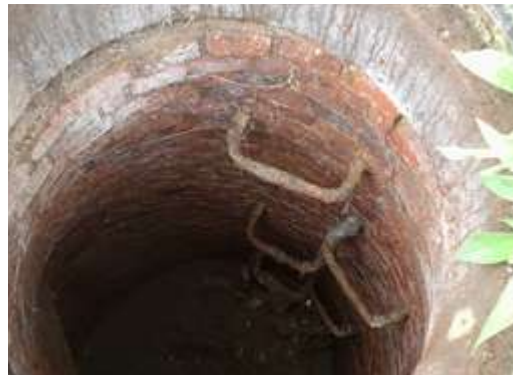
Defect 2

frame leaks

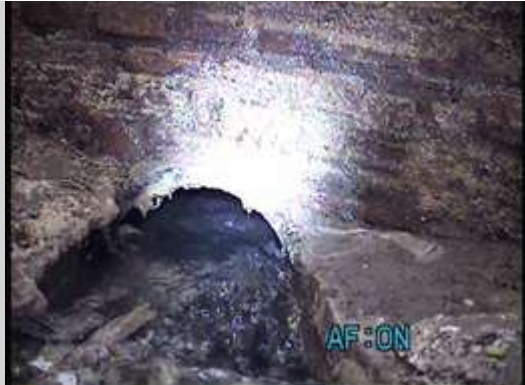
12 O'Clock Outflow

8 in. Circular Gravity Sewer
Pipe Out @ 12 O'Clock

Pipe Height: **8.4** (in.) Rod and Bar (Angled)
Pipe Material: **Clay** ☐ Pipe Lined
Invert Depth: **10.55** (ft.) Flow Characteristics: **Fast**
Deposits: ☒ None ☐ Mud ☐ Sludge ☐ Debris ☐ Grease
Silt Depth: (in.) Deposits Extent:
Infiltration: **None** Pipe Seal Cond: **Sound**

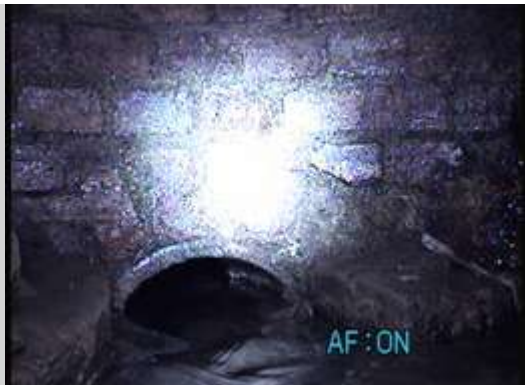
3 O'Clock Inflow

8 in. Circular Gravity Sewer
Pipe In @ 3 O'Clock

Pipe Height: **8.4** (in.) Rod and Bar (Angled)
Pipe Material: **Clay** ☐ Pipe Lined
Invert Depth: **10.60** (ft.) Flow Characteristics: **Fast**
Deposits: ☒ None ☐ Mud ☐ Sludge ☐ Debris ☐ Grease
Silt Depth: (in.) Deposits Extent:
Infiltration: **None** Pipe Seal Cond: **Sound**
